Sanitary Pipeline Pilot Project After 42-Years of Service in Lima Ohio

Jeff Boschert, P.E., Brian Browne, P.E, CPESC.,
Kent Carlson, and Steven Kayatin, P.E.

The Vernon Heights Polyvinyl Chloride (PVC) gravity sanitary sewer was constructed in 1976 for Allen County, Lima, Ohio. This installation was a trial of PVC (SDR 35) as a new material in the system. Fourteen sanitary sewer lines of eight-inch pipe were installed using the material. As a trial, these flexible pipes have been inspected and documented four times over their forty-two years of service.

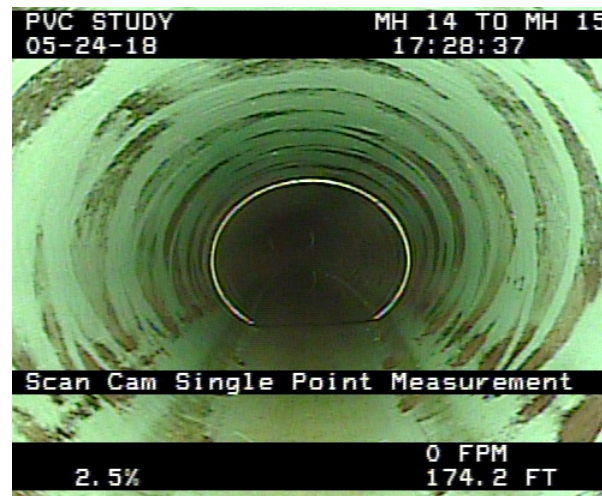
Figure 2: A CCTV image from the location of a single point scan in the Lima Study

the condition of all of the pipe. CCTV images were captured in the initial run of the pipe (see Figure 2) and the same pipe was laser-profiled on the return trip.

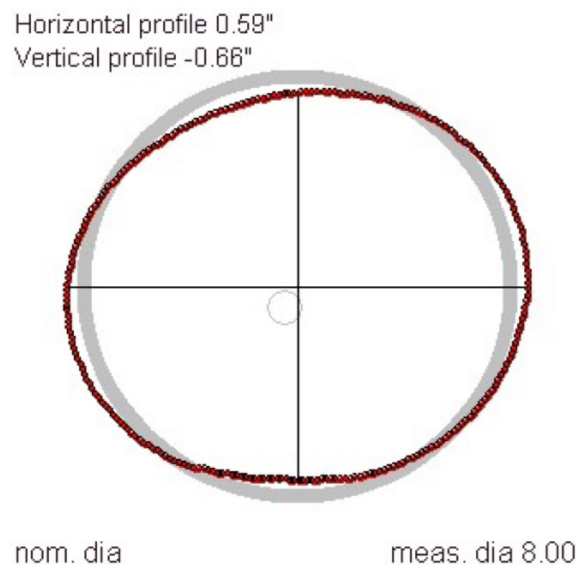
Racking or diagonal deflection is a deflection which does not occur in the vertical and horizontal dimension, but as a shifting of the pipe alignment at a specific point in the line as shown in Figure 5.

Figure 5: A point scan showing racking of the line.

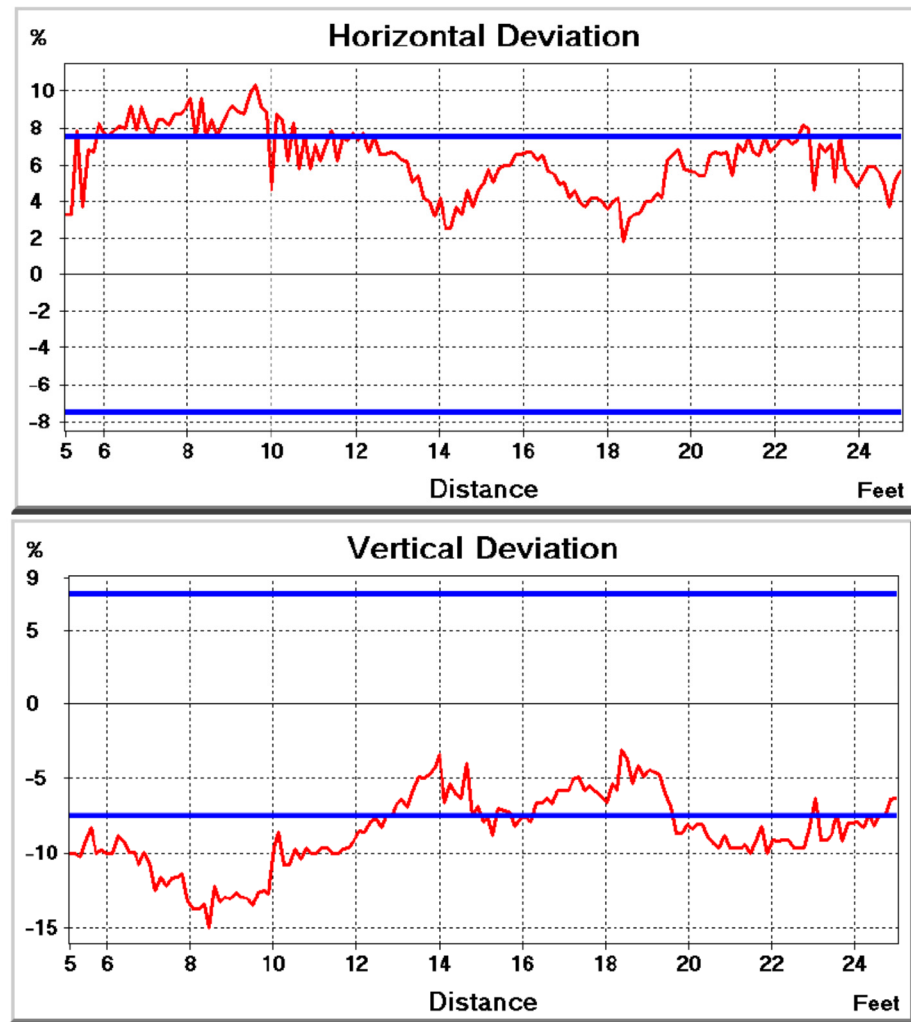
The software creates a 2D graph (Figure 6), showing the range of deflection of the entire run in the horizontal and vertical axes, and a 3D view of the entire run (Figure 7). These graphs show any deflection, the average pipe diameter, and the inclination slope of the line. These are immediately available to the operator/inspector. The scans can then be reviewed on-site to determine if it is necessary to re-enter the pipe and perform single scan measurements at areas of particular concern.

Figure 6: The line scan of 25 feet of pipe in the Lima Study (manhole 19 to manhole 12).

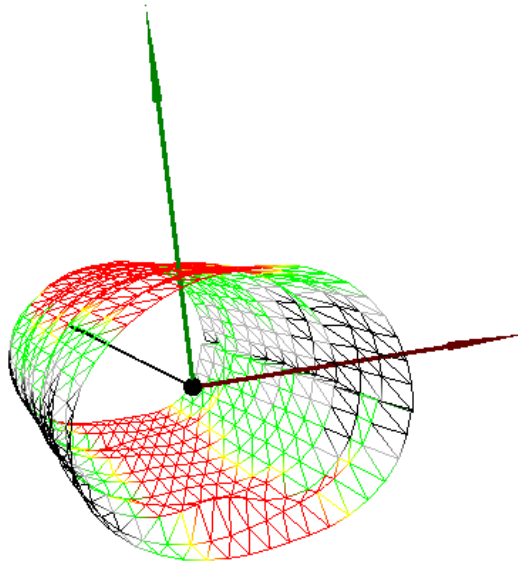
In the Figure 7, sample 3D view, the areas in red exceed the maximum allowable deflection of 7.5%. The areas in yellow have exceeded 4% deflection, but are not yet beyond the maximum.

Figure 7: Sample of a spinning laser scan from the Lima study inspection run from manhole 17 to manhole 16.

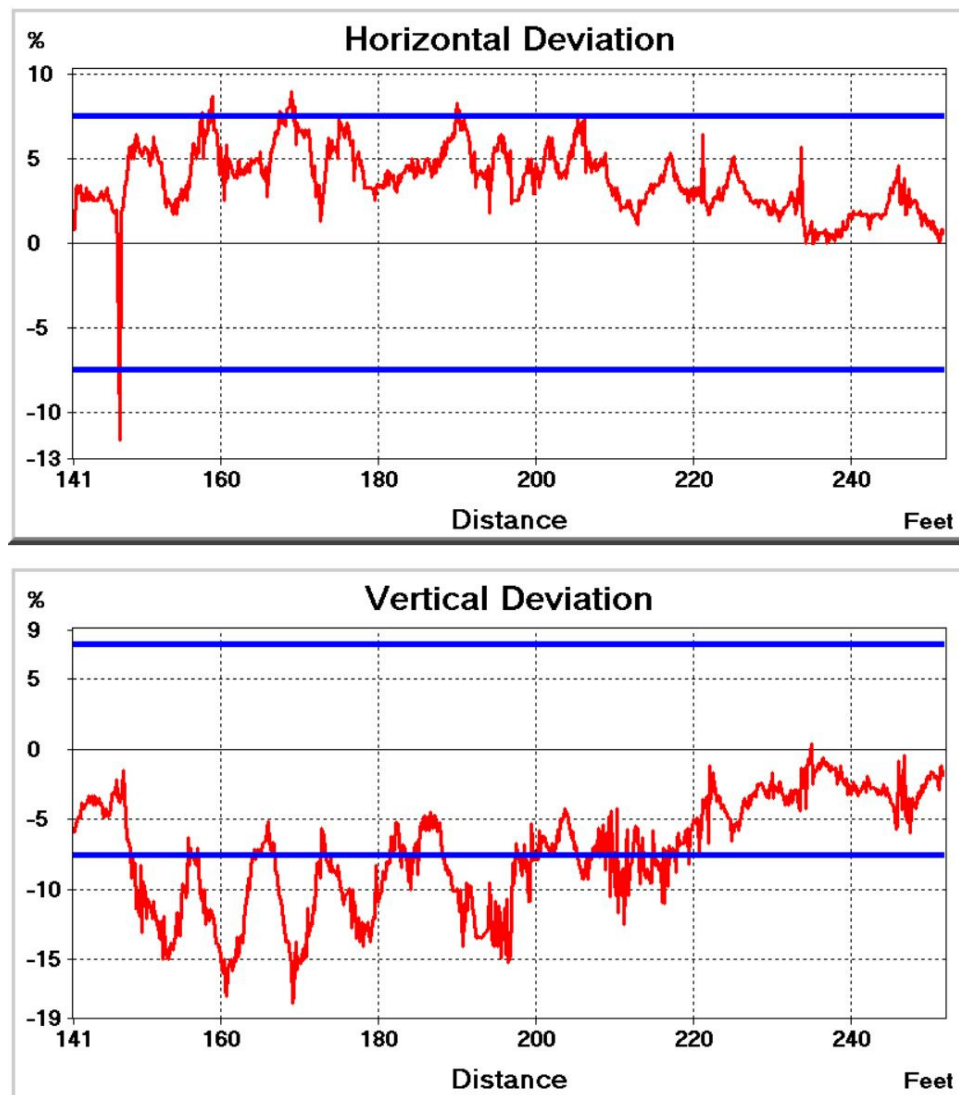
The much more detailed report created by laser profiling enabled a full profile of the complete lines as seen in Figure 8. The previous inspections were limited to identifying the point in the line beyond which the 8.5% mandrel would not pass. It is possible that the most serious concerns weren't identified in previous testing because they were beyond the point of failure. The deflections documented in 2018 show continuing vertical deflection within the segments of pipe that were measured in 1989.

The laser profile identified two lines with 17% deflection, one line with 19% deflection and one line that surpassed 30% deflection.

Figure 8: Sample of the Horizontal and Vertical line scan from the Lima study inspection run for 141 – 250 feet from manhole 17 to manhole 16.

The pipelines in this trial have been prioritized for replacement.
