**North American Society for Trenchless Technology (NASTT)
NASTT's 2014 No-Dig Show**

Paper # MA-T5-02

**Pilot Tube Microtunneling Chosen in Omaha Nebraska
for 585', Single Drive with Depths Reaching 50'
to Preserve Sensitive Garden Area**

Case Study: Pilot Tube Microtunneling project: 30" Diameter Storm Sewer
Project: Lauritzen Gardens Sanitary and Storm Sewer Separation Project
Owner: City of Omaha, Nebraska
Engineer: HDR; Omaha, Nebraska
Contractor: Horizontal Boring & Tunneling Co.; Exeter, Nebraska

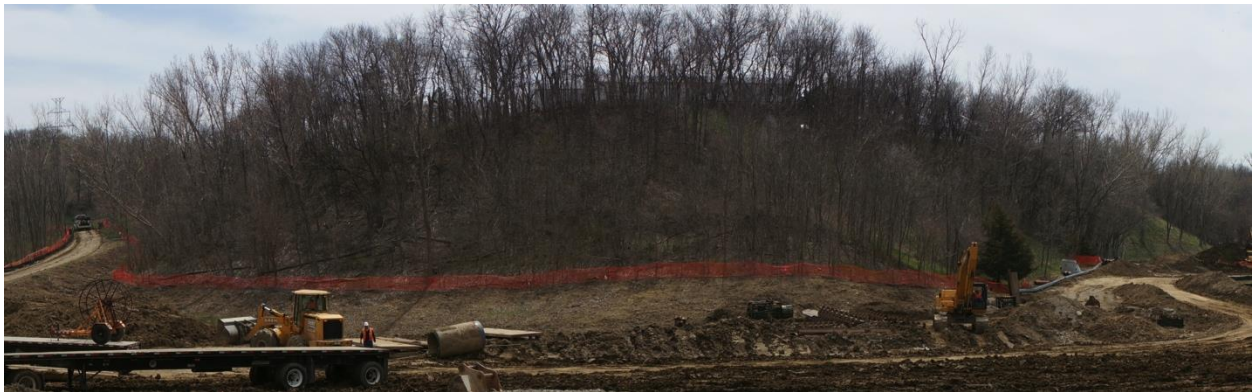
FIGURE 3: Tree-covered hill obstructed line of sight

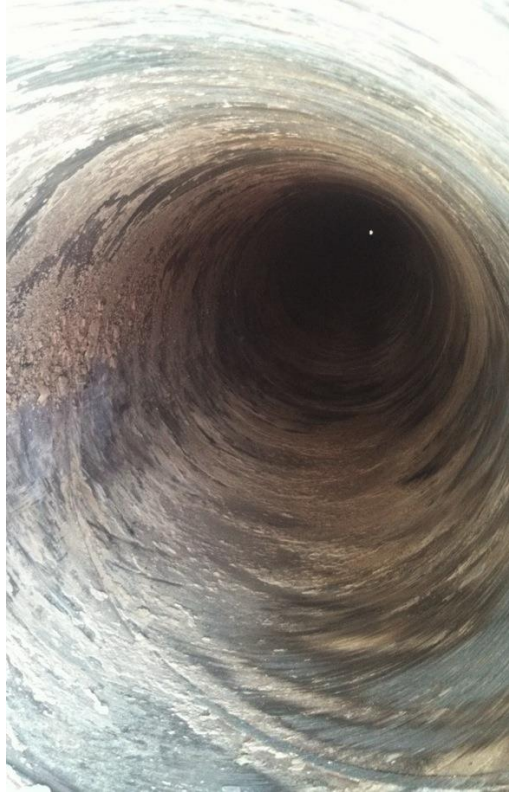
The harder than expected soils and stiffness of the welded casing string made the attempt to smooth the alignment at the intersect point problematic. When the 24" temporary casing reached the intersect point in the original pilot tube path, the auger began to bind against the casing, indicating the auger was following the pilot tube through the slight bend, while the casing was continuing in a straight line. In order to alleviate some of the pressure, a bit was inserted to provide greater overcut in an attempt to get the casing to follow the pilot tube alignment. Use of a rock bit did not alleviate the bind, and when the rock bit was removed, it was apparent the swivel between the auger and pilot tube had been destroyed. In order to get a 24" casing through the entire crossing, the augers were removed from this casing and moved to the other pit (on the downhill side) where a second auger boring machine was set up to drive the remaining length in the opposite direction. The casings didn't meet up as desired, so the 24" temporary casing string could not be tied together. The crew began to remove casing from the downhill shaft by pulling it out while the other string of casing was augered and pushed down through from the uphill shaft. The crew was able to periodically inspect the behavior of the 24" casing being pushed downward from inside of the 24" casing being pulled out. Using this push-pull technique, the crew was able to achieve a continuous 24" temporary casing through the entire run, although the bend was still present, daylight could be seen through the 24" casing (See Figure 7).

FIGURE 7: View through the 24" temporary casing

After careful consideration of the current conditions and goals for the project, the decision was made to push the 38½" casing with 36" auger from the uphill shaft downward, while pushing out the 24" temporary casing. In order to connect and center the 38 ½" casing on the 24" casing, Horizontal Boring & Tunneling Co.'s fabrication shop produced an inverted top hat that would go inside the 24" casing and accommodate a swivel that attached to the hex on the 36" auger. This resulted in a similar configuration as before, where the 36" auger was connected directly to the 24" temporary casing. A rock bit was used and the crew began to push casing. Again, the crew encountered grinding near the point of intersect and the swivel connection was destroyed. The crew entered the casing and removed the top hat connection allowing visual inspection of the alignment. The 38 ½" casing was having trouble making the slight bend. The crew resumed the push-pull technique by pulling 24" temporary casing out from the downhill side with one boring machine while pushing 38 ½" casing downhill from the topside. Periodic visual inspection indicated the 38½" casing was on grade, but deviated from alignment. This deviation worsened in the softer soils towards the end of the crossing, but since grade was holding true, the crew continued to push. Once the casing emerged, the result was that the downstream end of the drive was out of alignment by approximately 3', with most of the alignment deviation occurring on the downhill end of the crossing in the softer soils.

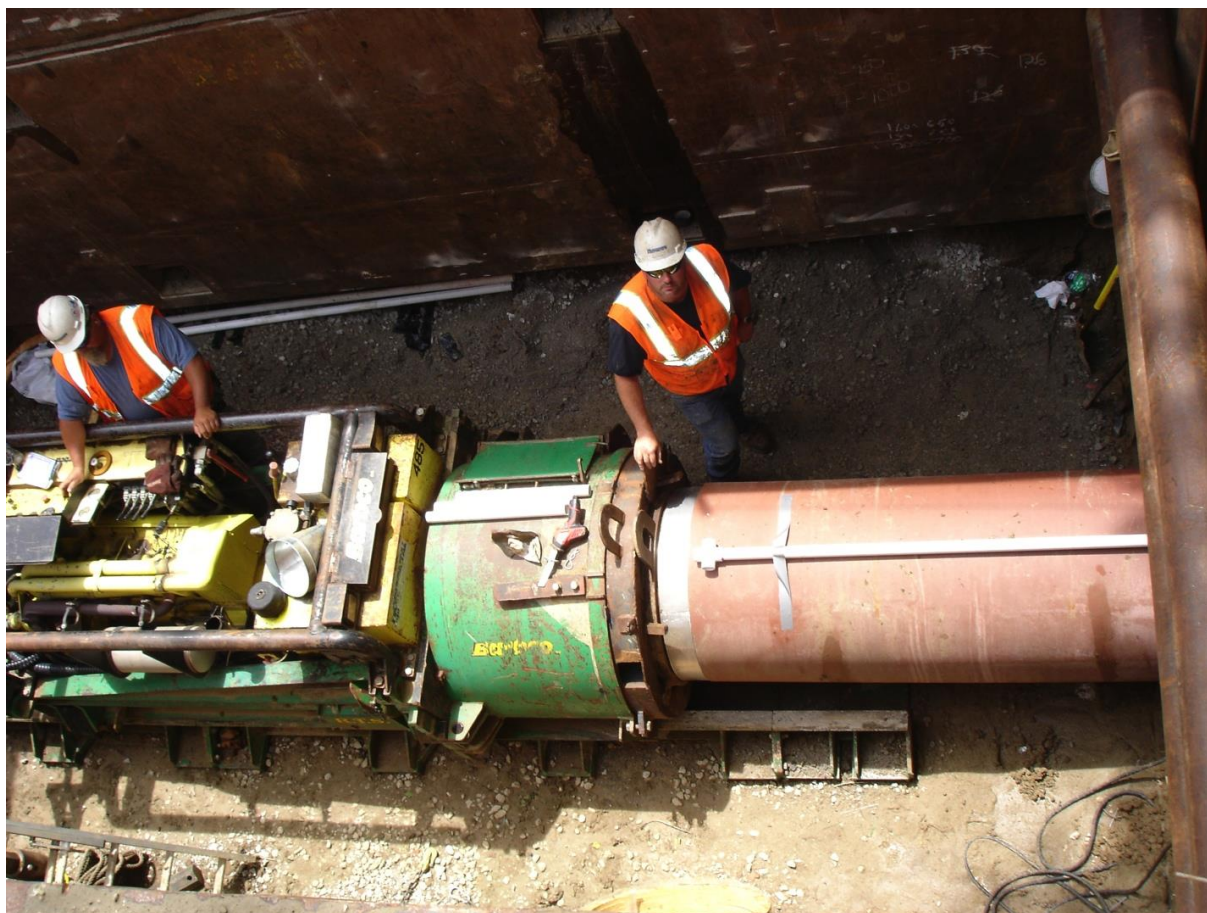
FIGURE 8: Jacking the 30" VCP in the final step became the smoothest part of the installation

With the path established by the 38.5" temporary casing, VCP was used to jack the casings out of the tunnel. The crew attached a 2" PVC line on top of the VCP in order to convey CLSM (Controlled Low-Strength Material) or flowable fill to fill the annular space at the completion of the installation (See figures 8 and 9). Some bentonite lubrication was used during VCP installation, but with an established alignment and hard clay soils, this became the smoothest portion of the project and was completed in just two days.

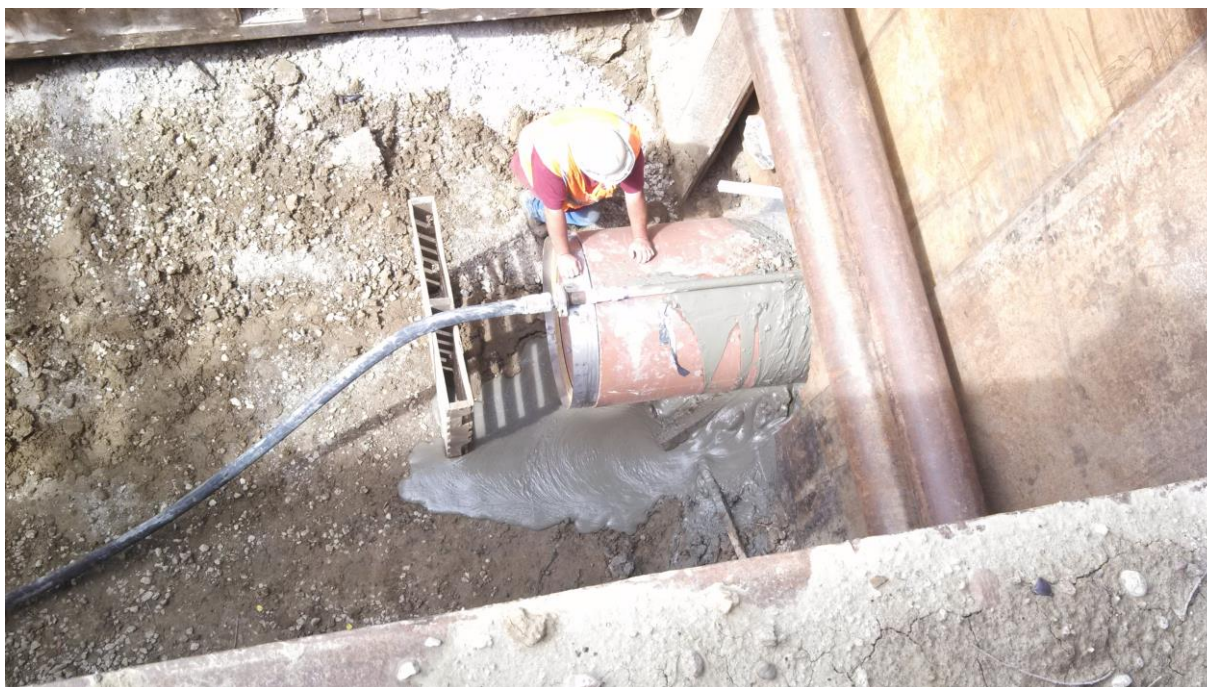
FIGURE 9: Pumping CLSM to fill the annular overcut
