EARTHQUAKE
DAMAGE EVALUATION
AND
DESIGN CONSIDERATIONS
FOR
UNDERGROUND STRUCTURES

A
PUBLIC
SERVICE
PAPER

AMERICAN SOCIETY
OF CIVIL ENGINEERS

SANITARY SEWERS

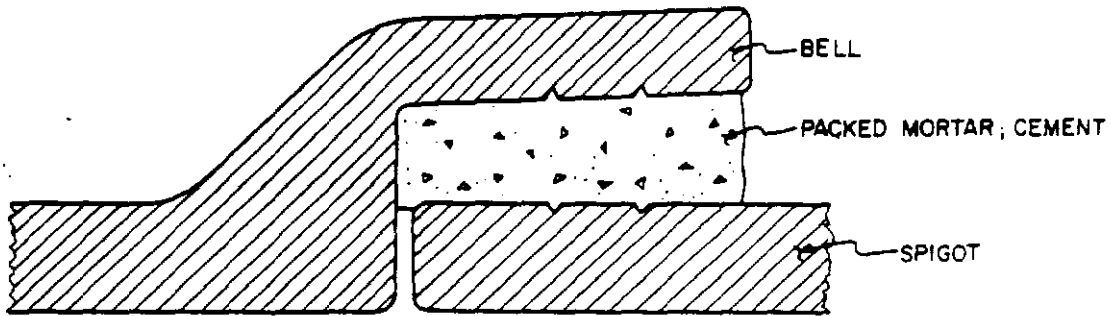
TYPICAL RIGID PIPE JOINT - MORTAR PACKED TYPE

basically two types of joints existing in the area. The first is a mortar joint which is considered to be rigid in the Table. This joint is shown on Figure 4. The second type of joint is the plastic compression joint which is also shown on Figure 4. This type of joint has come into almost universal usage in California in the last fifteen years. Polyvinyl chloride was initially used as the compression ring material. However, polyurethane is more commonly used now. This is considered to be a flexible joint, as eight-inch diameter pipe may be deflected up to two degrees and eighteen-inch diameter pipe may be deflected up to one and one-quarter degree.

1. For all sizes of clay pipe, the flexible joint pipe suffered significantly less percentage damage than the rigid joint pipe. Generally, the larger the size, the greater the advantage the flexible joints provided.
2. Pipe size appears to have a relation to damage. The greatest

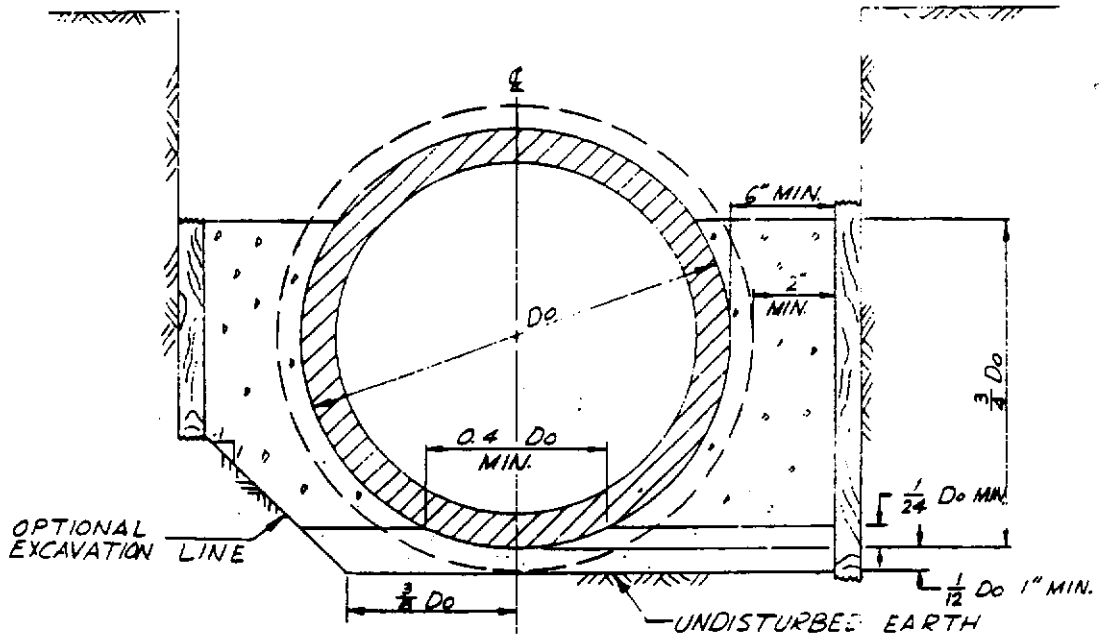
TYPICAL PARTIAL ENCASEMENT

Encasement involved was both partial and complete concrete encasement. These two different types of encasement are shown on Figure 5. For purposes of this study, these two were lumped together. As noted earlier, there are only 3,000 feet of 21-inch sewer within the damaged area. This pipe is located at the lower boundary of the area. All 3,000 feet are rigid joint pipe, unencased, and none was damaged. Because of the limited quantity and the single type of pipe, no conclusions are made with respect to this size in this report.

3. The percentage damage which occurred to encased pipe is not consistently related to the damage in non-encased pipe.

5. There do not appear to be any major revisions in current design procedure which are indicated as a result of this investigation.
6. It is recommended that where encasement must be provided, that joints be placed at appropriate intervals (not exceeding 30 feet). Such joints should be located at the end of the bells of the vitrified clay pipe.
