# Plumbing Engineer

# Discovering Why Pipes Fail

By Steve Ferry

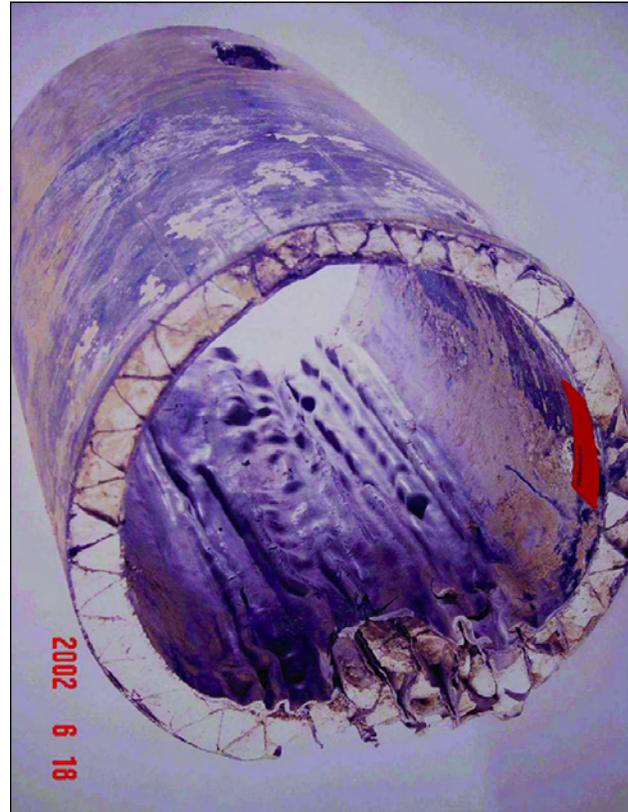
*Figure 1 — Section of ABS truss pipe affected by long-term exposure to drycleaning solvents.*

Hauser received three samples of 12-inch nominal ABS truss pipe from a Texas utility district, which used the pipe in a sanitary sewer application. ABS truss pipe consists of a coextruded ABS shell filled with portland cement. Upon receipt, the samples were inspected and found to contain an axially oriented area of damaged ABS, such that under ring compression the pipe had buckled. This buckling reportedly occurred at the 6 o'clock position in the sewer system, which is consistent with a gravity flow system. The ABS appeared to be damaged due to chemical attack, and displayed evidence of softening, possibly due to exposure to solvents. The softened ABS had subsequently altered shape and dimensions (see Fig. 1).

Hauser performed a failure analysis, with one main component of the failure analysis being heated headspace gas chromatography (mass spectroscopy), HHGC-MS. The GC-MS test results indicated the presence of perchloroethylene, in quantities greater than 1000 ppm, in the wall of the ABS at the 6 and 12 o'clock positions. Trichloroethene was also found. It is

known that perchloroethylene is used for drycleaning, and the damage to the sewer system was isolated to an area directly downstream from a commercial drycleaning operation. Subsequent testing by the municipality confirmed that the drycleaner was discharging solvents directly to the sanitary sewer system and was found liable for repairs.

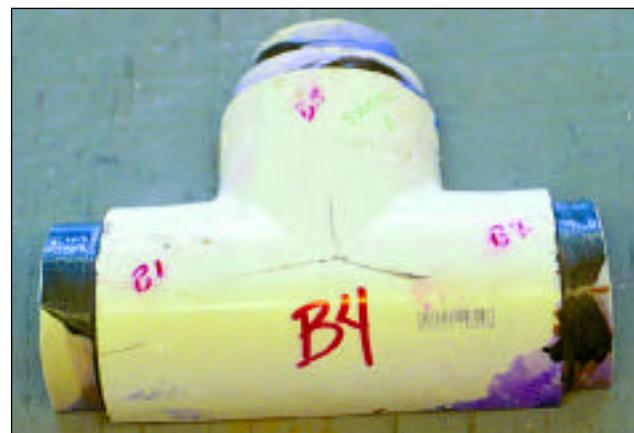
Figure 3 — Cyclic fatigue fracture of PVC tee used in water spraying system.

Hauser received two samples of 2-inch nominal solvent cement PVC tee fittings which had failed in service. The tees were portions of a Florida amusement park ride where water jets were constantly cycled on and off. The tees branched vertically from the 2-inch supply line for approximately 6 inches, where the branch then changed directions 90 degrees (from the axis of the supply line). The system operated using recycled (potable) water. Hauser performed failure analysis, and in the process determined that the fitting samples displayed adequate workmanship of manufacture and assembly, adequate material strength, and were manufactured from an appropriate material. The fractures indicated a stress field was present which caused fracture that could only have come from operation of the system. This stress field ultimately caused a fatigue type failure in the fittings due to torsional loading of the fittings through the 6-inch lever arm, caused by water hammer as the water was cycled on and off repeatedly. The failures could have been eliminated by using a significantly more robust fitting and/or thrust blocking of the tee and lever arm of the pipe branch to reduce or eliminate the stress. □

**The failures could have been eliminated by using a significantly more robust fitting and or thrust blocking of the tee and lever arm of the pipe branch to reduce or eliminate the stress.**
