Sanitary Pipeline Pilot Project After 42-Years of Service in Lima Ohio

Jeff Boschert, P.E., Brian Browne, P.E, CPESC.,
Kent Carlson, and Steven Kayatin, P.E.

The Vernon Heights Polyvinyl Chloride (PVC) gravity sanitary sewer was constructed in 1976 for Allen County, Lima, Ohio. This installation was a trial of PVC (SDR 35) as a new material in the system. Fourteen sanitary sewer lines of eight-inch pipe were installed using the material. As a trial, these flexible pipes have been inspected and documented four times over their forty-two years of service.

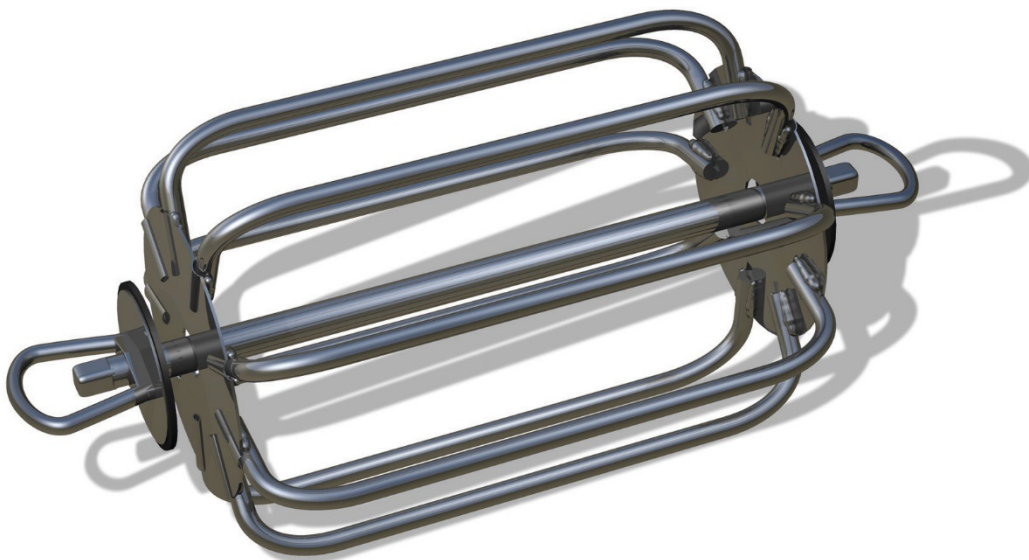
The original acceptance testing was conducted eight months after installation and before the lines were placed into service. The go/no-go test indicated that all fourteen PVC lines passed a 5% mandrel test using a 7.5-inch, rigid, 9-leg mandrel (See Figure 1). Six years later, in July of 1982, all of the lines were retested using 5% (7.5-inch), 6.5% (7.38-inch) and 8.5% (7.22-inch) mandrels. Another seven years later (after 13 years of service), in August of 1989, another mandrel test of all fourteen lines was performed.

Figure 1: Rigid, nonadjustable, go/no-go 9-leg mandrel used in deflection testing.

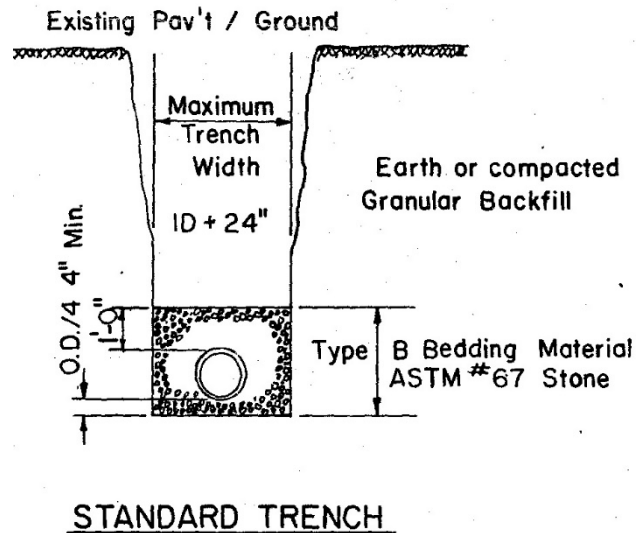
This project had cover depths of 8- to 13-feet and trench widths of I.D. plus 12-inches on either side of the pipe. The pipeline was bedded with compacted #67 crushed stone (Class I material per ASTM D2321) on both sides and 12-inches over the top of the pipe as required by the county's General Specifications (see Figure 3).

Figure 3: Typical sewer trench from Appendix B of Allen County's General Specifications, 1976

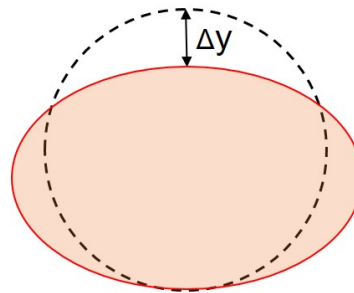
Ovaling is the bulging out along the springline with a corresponding reduction in height along the vertical axis. This is illustrated in Figure 4.

Figure 4: Ovaling deflection illustration courtesy of American Concrete Pipe Association (ACPA)
