KNOW YOUR LIMITATIONS

A Guide to Analyzing Televised Inspection

NATIONAL CLAY PIPE INSTITUTE

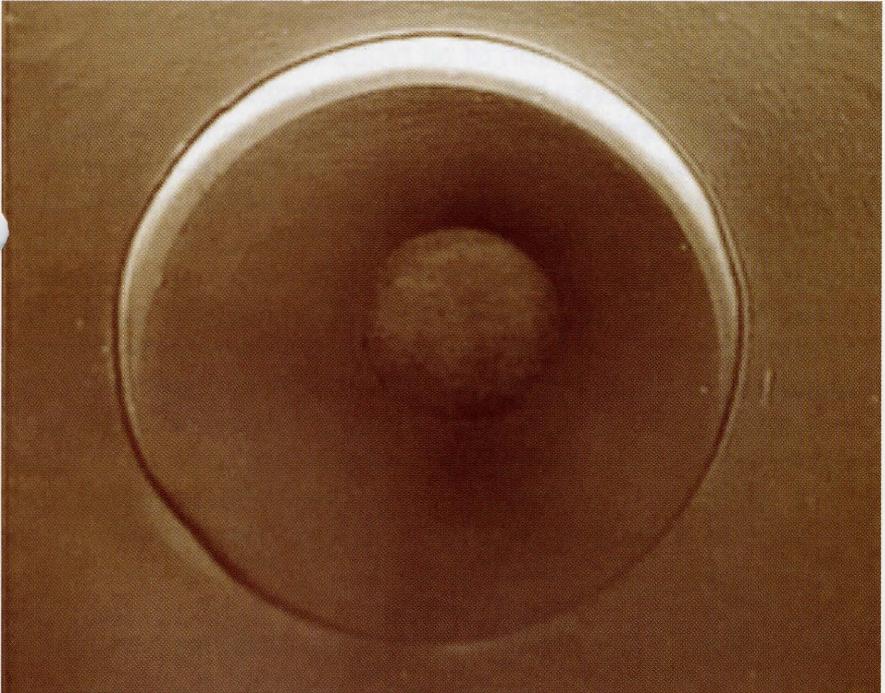
Cover illustration depicts illusion of an offset joint when in reality the pipe is in straight alignment and there is no offset.

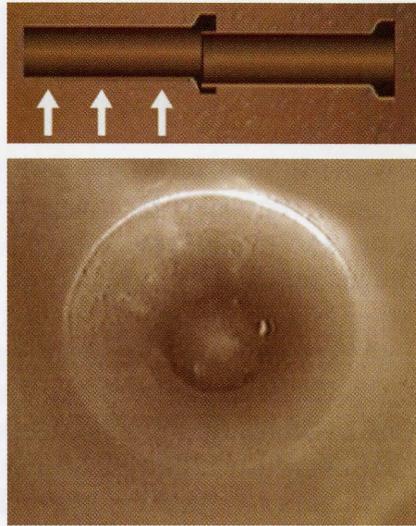
Joint offsets during construction must be kept within allowable tolerances. Joint end trim may give the illusion of a parallel offset. Note the distortion of these minor offsets as they may appear much larger than actual. Observe the camera as it moves over the joint. If the camera tilts up or down this gives some indication of the magnitude of the offset.

8-inch diameter pipe with $\frac{1}{4}$ " offset

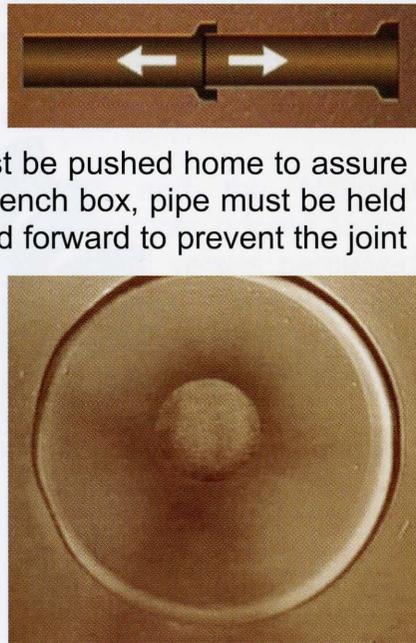
During construction, joints must be pushed home to assure joint integrity. When using a trench box, pipe must be held in place when the box is moved forward to prevent the joint from pulling apart. If joints have been pulled, a gap will result between the pipe ends. The joint design for clay pipe provides an allowance for joint gap without sacrificing integrity. Consult the manufacturer or local standards for gap allowances. Note the appearance of the pulled joint.

8-inch diameter pipe with joint pulled $\frac{3}{8}$ "

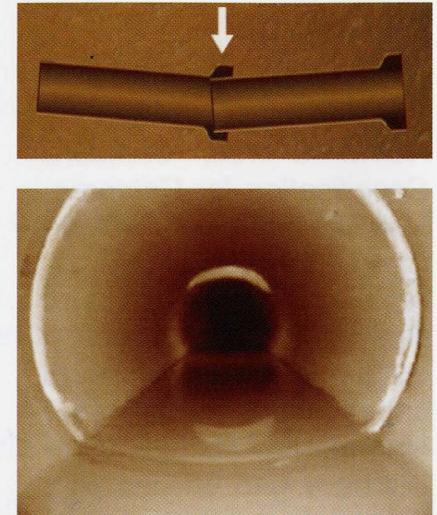
All pipelines experience some settlement under load which is due to the pipe bedding not the pipe itself. After cleaning or testing, water may remain in the line for a lengthy period where the line is at a very flat grade. It may take a day or more for the water to completely drain from the line to accurately expose low points. Estimating the depth of the water is very difficult. If viewing video with no dimensional reference point, scale the necessary dimensions from the screen and apply basic geometry. This method has limited accuracy.

8-inch diameter pipe with $1\frac{1}{2}$ " depth of water.

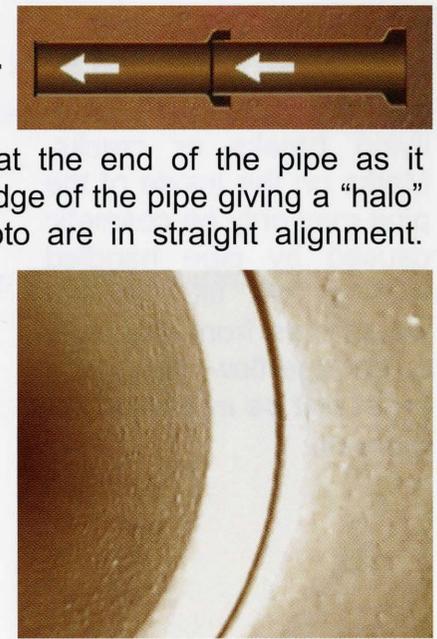
The camera is not looking at the end of the pipe as it appears but at the trimmed edge of the pipe giving a "halo" effect. The pipe in the photo are in straight alignment. However, because the camera is looking *into* the joint (remember the wide-angle lens), the illusion of an offset, deflected or pulled joint may appear. Also, the factory trimmed ends of the pipe may not be perfectly concentric with the pipe presenting the illusion of an offset joint.

8-inch diameter pipe with no offset showing "halo" effect.

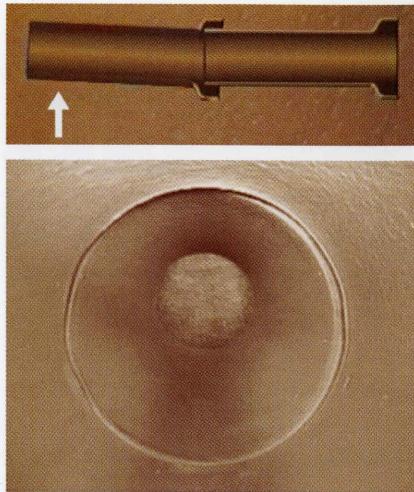
ASTM C 425, *Standard Specification for Compression Joints for Vitrified Clay Pipe and Fittings*, requires clay pipe joints to seal in angular deflection up to a specified maximum depending upon the pipe diameter. Although there will be a gap on one side due to the angular deflection, the other side is completely tight. Note the appearance of this condition.

8-inch diameter pipe with angular deflection.

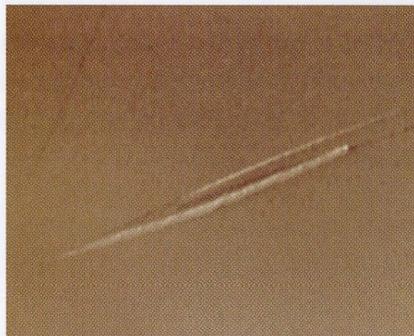
Be very careful in identifying breaks or cracks. Marks on the inside of the pipe may only be cosmetic caused by pipe handled with a fork lift, residual water lines from cleaning, or sewage flow marks and **must not be mistaken for a crack.**

8-inch diameter pipe with harmless surface marks.
