# Analyzing CCTV Inspection of Vitrified Clay Pipe

**NATIONAL CLAY PIPE INSTITUTE**

The goal of this handbook is to serve the needs of CCTV camera operators and their utilities by providing clarity around common issues when using CCTV to inspect Vitrified Clay Pipe (VCP) lines. Each specific condition is highlighted on a separate page with an illustration of the condition and a CCTV image from inside the pipeline.

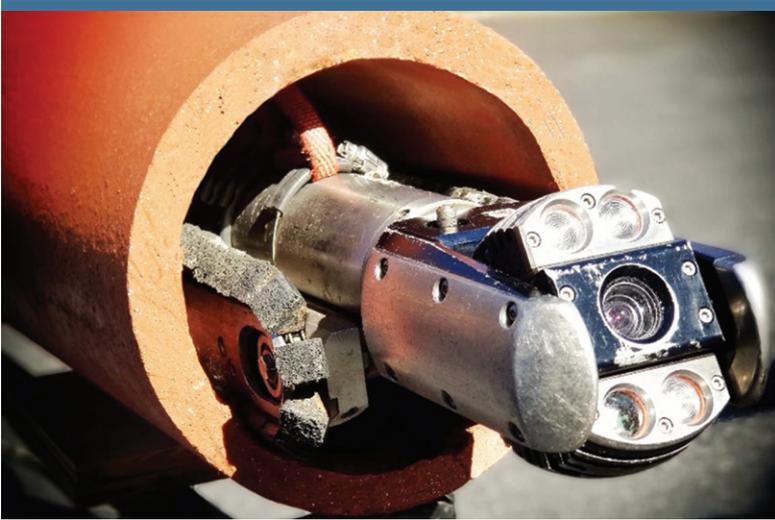
*Figure 1: A CCTV camera in an 8" pipe.*

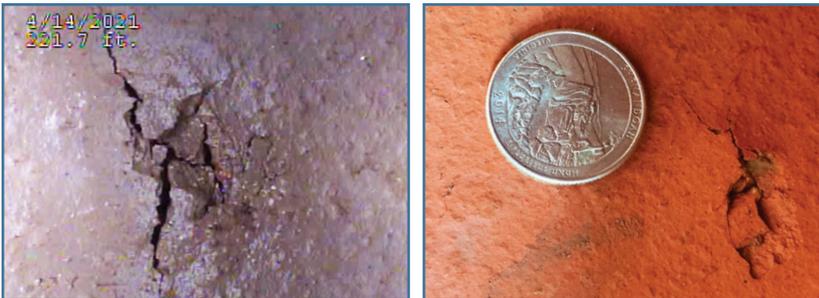
*Figure 2: The picture at left was the observed condition of an 8-inch pipe in a CCTV inspection. The photo at right is the recovered pipe that passed the air test. The cosmetic imperfection is well-within the chip allowance specified in ASTM C700 and would have had no impact on long-term performance. For more examples of cosmetic imperfections, see pages 18 & 19.*

Of the various pipe materials found in sanitary sewers throughout the U.S., VCP will frequently be the oldest sewer pipe in a collection system. As a kiln-fired ceramic, VCP is a natural material with some dimensional and cosmetic variations being normal, such as the “lime pop” in the pictures on page 2. A small piece of lime may occasionally be close to the pipe surface after extrusion. During firing, this lime may “pop” and result in the marks seen in Figure 2 on page 2. These should not be regarded as a cause for rejection.

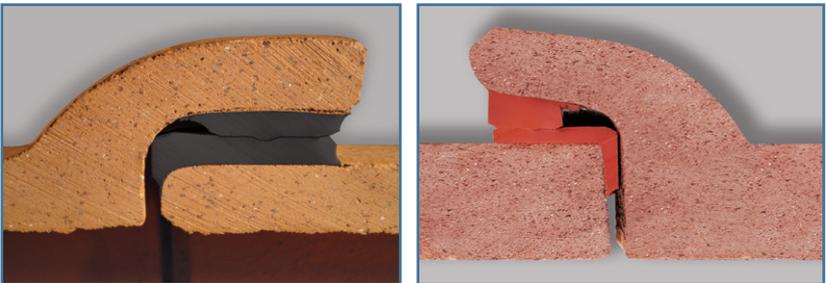
*Figure 3: Vitrified Clay Pipe cross-sectional compression joint designs for Bell & Spigot pipe. Note the trim/ chamfer on the spigot and bell ends, as well as the "gap" on the fully homed joint.*

As the joint cutaway photos on pages 5 and 6, (Figures 3, 4, 5 & 6) show, variations in color are still common, but no pipe currently manufactured in the U.S. is glazed.

Clay pipe manufacturers made a variety of adjustments to the original joints to address this recommendation, but the most important aspect of these was the “seismic cushion” as part of the spigot-end gasket. This design creates an intentional gap within the fully-homed joint assembly to allow for axial movement and prevent hammering. This flexible compression joint design encompasses a raised bead molded within the bell-end gasket to provide a connection that allows for angular deflection, shear load resistance, axial compression, and limited pullout (see Figure 3 on page 5). This became the first “seismic joint” design introduced to the industry.

As is apparent in the joint designs pictured in Figures 3, 4, 5 and 6 it is impossible to “over-home” a VCP joint.

Before the first observation is made, it is important that the operator and reviewer fully understand the operation and capabilities of the equipment as well as the pipe material and joint design to be inspected. (See figures 3, 4, 5 and 6 on pages 5 and 6 showing joint designs currently in use).

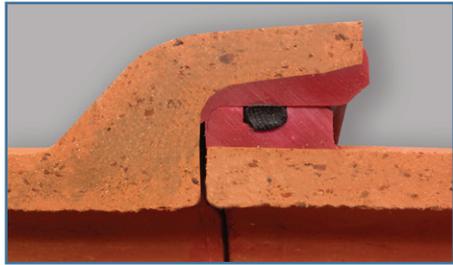
*Figure 4: This joint design compresses a rubber O-ring between two dimensionally precise surfaces to achieve a water tight seal while allowing for normal amounts of angular deflection and shear load.*

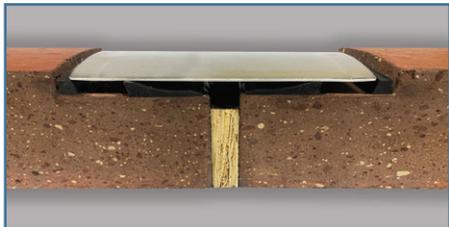
*Figure 6: VCP jacking pipe joint.*

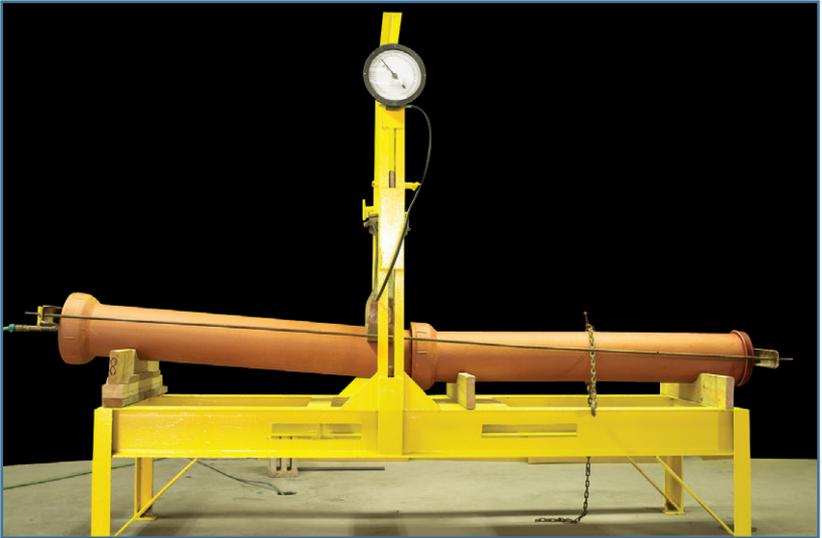
*Figure 7: 8-inch Vitrified Clay Pipe laboratory testing with a vertical angular deflection at the joint of 1/2-inch per foot. VCP joints are required to pass this test with zero leakage.*

Pipe and the jointing system are tested in the lab in accordance with ASTM C425 (*Standard Specification for Compression Joints for Vitrified Clay Pipe and Fittings*). These tests include angular deflection at the joint, an external load is applied and the pipe is filled with pressurized water. In order to pass this test there must be no leakage.

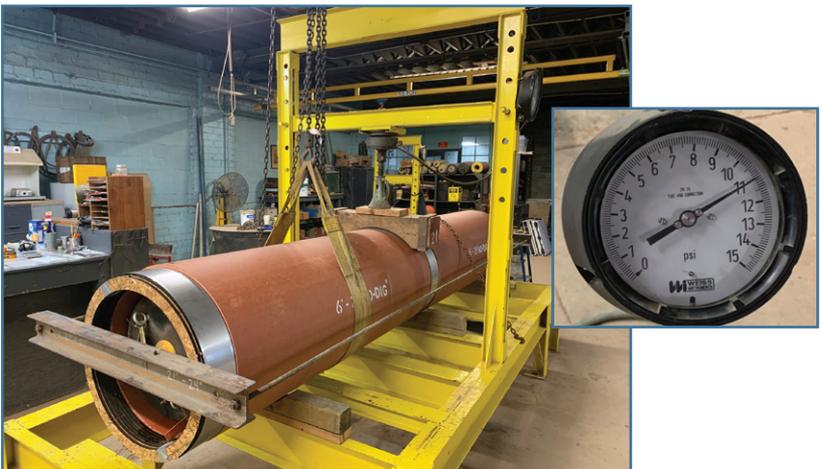
*Figure 8: 21-inch VCP Jacking pipe passing the same test.*

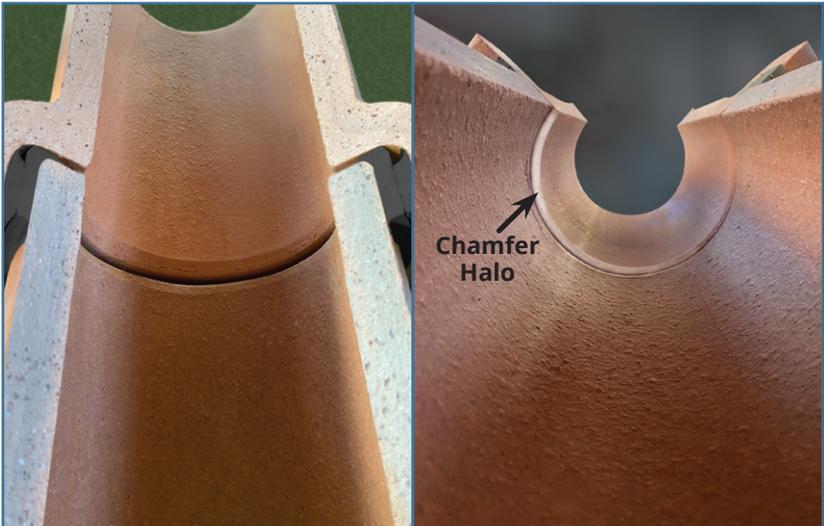
*Figure 12: Both photos above are of the same joint cross section. The image on the left shows that it is fully-homed and sealed. This same joint, viewed from the angle of a CCTV camera, (right image) shows how the gap from the seismic cushion in combination with the chamfer can reflect the light from the camera creating a halo.*

The camera is not looking at the end of the pipe as it may appear, but at the trimmed/ chamfered edge of the pipe giving a halo effect. The pipe in the photos are in straight alignment. However, because the camera is looking into the bell end of the pipe, it may create an illusion of an offset, deflected or pulled joint. This illuminated halo can lead operators to incorrectly code this condition as a parallel offset or even a pulled joint.

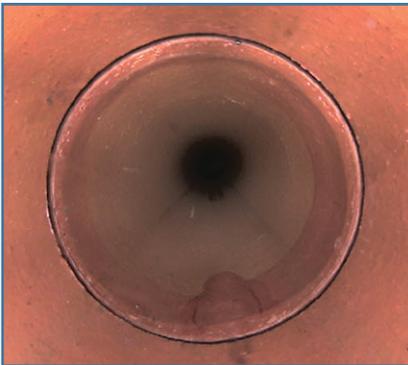
*Figure 14: Straight Alignment - approaching*

Also, the factory trimmed ends of the pipe (as shown in Figure 14) may not be perfectly concentric with the pipe presenting the illusion of an offset joint. The two images shown below are of a fully homed joint connection with no gap or offset.

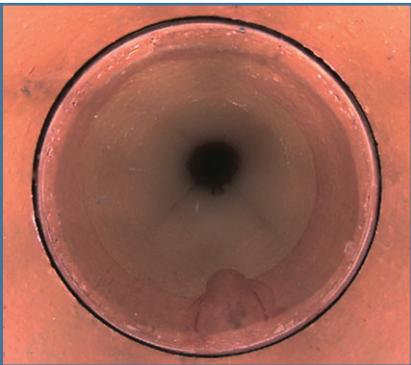
*Figure 15: Straight Alignment - close-up*

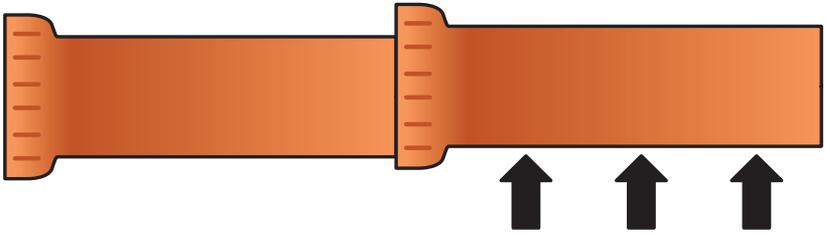
*Figure 16: Joint offsets can occur during construction. If they are within allowable tolerances, they will not affect the performance of the pipeline.*

Joint offsets during construction must be kept within allowable tolerances. Differences in roundness and dimensional inside diameter should be within tolerances for the pipe as specified in ASTM C700 and ASTM C1208. These variations should not be considered a parallel joint offset. Joint end trim may give the illusion of a parallel offset. Note the distortion of these minor offsets as they may appear much larger than actual. Observe the camera as it moves over the joint. If the camera tilts up or down this gives some indication of the magnitude of any offset.

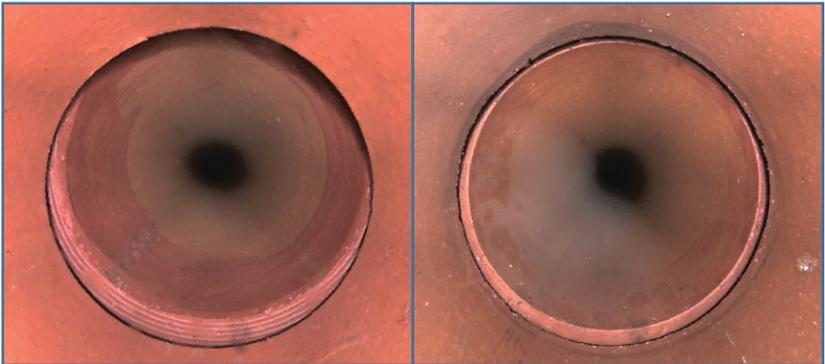
*Figure 17: 5/8-inch Parallel Offset  
Bell/Spigot gaskets removed for illustration purposes*

*Figure 18: 3/8-inch Parallel Offset  
Bell/Spigot gaskets poured non-concentric for illustration purposes*

If an offset is within ASTM standards or if it passes a Low-Pressure Air Test, it will not effect the performance of the pipeline or the integrity of the pipe.

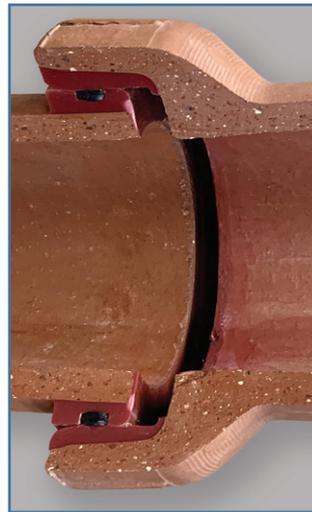
*Figure 20: While this joint cutaway shows a significant gap in the pulled joint for illustration purposes, the joint holds and would perform as specified.*

During construction, joints must be assembled to assure pipeline integrity. When using a trench box, pipe must be held in place when the box is moved forward to ensure the assembled joint does not pull apart. If joints have been pulled, a larger gap may result between the pipe ends. The joint design for clay pipe provides an allowance for joint gap without sacrificing pipeline integrity, see Figures 19 & 20.

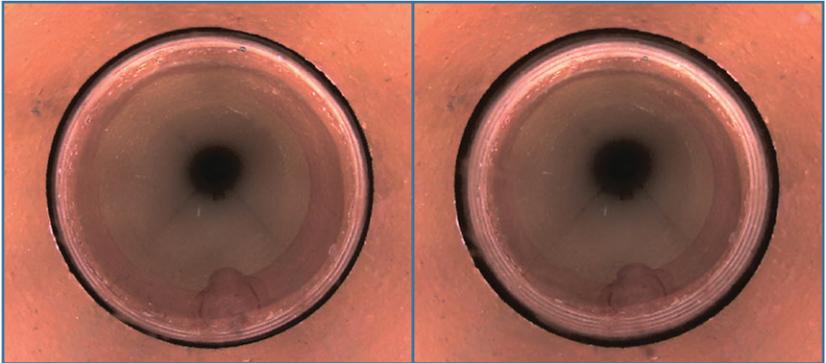
The images below show a  $\frac{3}{8}$ -inch and a 1-inch joint gap as viewed with the CCTV camera. Both joints passed a Low-Pressure Air Test to verify joint integrity.

*Figure 21:  $\frac{3}{8}$ -inch Pulled Joint (gap)*

*Figure 22: 1-inch Pulled Joint (gap)*

Whenever there is doubt about the integrity of the joint seal, the Low-Pressure Air Test is recommended. If the installation passes the Low-Pressure Air Test, pipeline performance and pipe integrity should be unaffected.

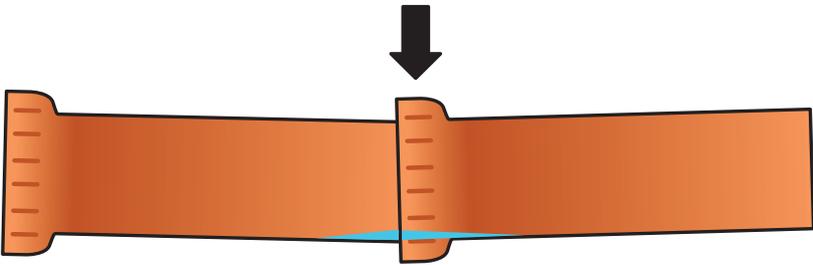
*Figure 23: Joint sags are sometimes intentional (as in the case of siphons) and sometimes they occur due to post-construction settlement.*

Any pipe can experience some settlement under load which may be due to insufficient bedding/ haunching, foundation support or other issues and not the pipe itself. If the settlement occurs at the joint, this is called a pipe sag. A minor joint sag may not affect the performance of the pipeline. After cleaning, water may remain in the line for a period where the line is at a flat grade. It may take a day or more for the water to completely drain and fully expose low points in the line.

Sags can be an intentional design feature such as in areas where siphons are constructed.

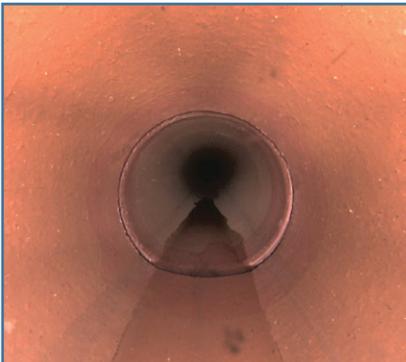
*Figure 24: 1/2-inch water depth*

Where sags occur, estimating the depth of the water is very difficult. This can be an issue no matter what pipe material is being inspected. If viewing video with no dimensional reference point, scale the available dimensions from the screen and apply basic geometry. An illustration of applying this method in an 8-inch pipe is seen in the *Estimating Depth of Flow* chart in Figure 26 below.

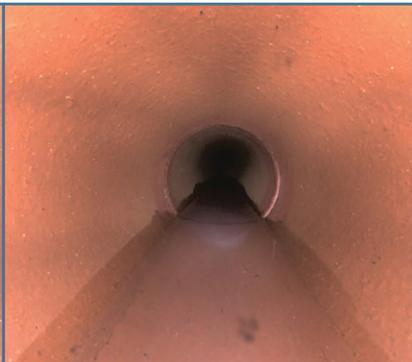
*Figure 25: 1 1/2-inch water depth*

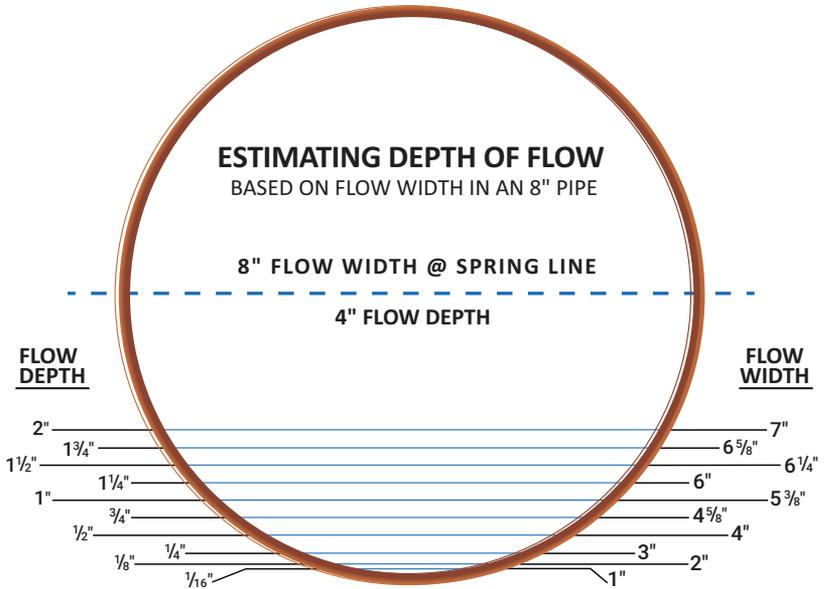
*Figure 26: In any pipe material, even a minor depth of water can appear exaggerated due to the optical illusion created by the periphery of the pipe.*

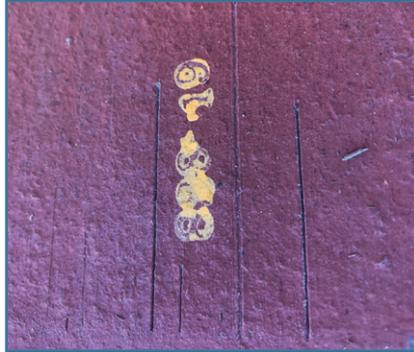
*Figure 27: Cosmetic Imperfection (caused by extrusion marks)*

Be very careful in identifying breaks, fractures or cracks. Marks on the inside of the pipe may only be cosmetic imperfections on the inside surface. These marks are commonly caused by handling with a forklift, residual water lines from cleaning, or sewage flow marks. These have, on occasion, been mistaken for cracks or fractures.

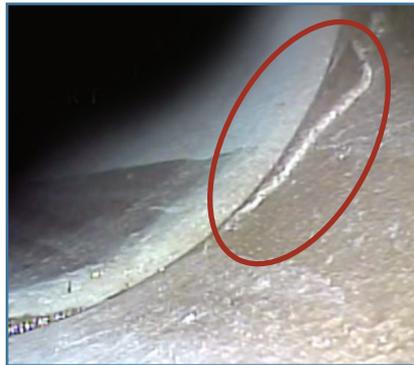
*Figure 28: Surface imperfection created during extrusion*

Figure 28 shows a piece of excess clay that fell from the pipe end trimmer/ finisher and was stuck/ pressed to the inside of the 6-inch pipe wall. This happened after the pipe was extruded and before it was kiln fired. After firing it was permanently bonded.

The thickness is less than  $\frac{1}{16}$ -inch but the lighting and the camera really exaggerates the blemish as it wasn't noticeable with the naked eye.

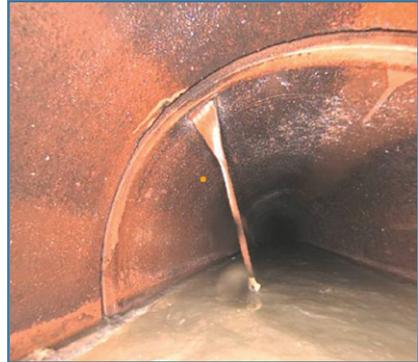
Figure 29 shows polyurethane material that ran down inside the pipe when the bell gasket was poured during manufacturing. Each pipe section stands on end vertically while the bell gaskets are poured within a mold inside the pipe bell. This material spill was missed and didn't get cleaned off before the pipe was shipped, installed and inspected.

*Figure 29: CCTV image of polyurethane gasket overpour*

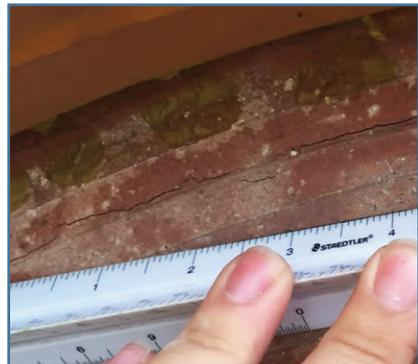
Crazing (also referred to as surface shrinkage, surface checking, firing checks or drying checks) is a common manufacturing condition on the surface of the pipe. This can occur on the inside surface of the barrel during the trim/chamfer process or on the outside of the barrel where the bell meets the body of the pipe. It does not affect the performance of the pipe in any way.

Crazing is a surface blemish that can occur anywhere on the pipe surface. It can be highly exaggerated by the CCTV light source and camera magnification during inspection.

*Figure 30: Crazing (pictured here) is common, but it has also been misidentified as a fracture or crack.*

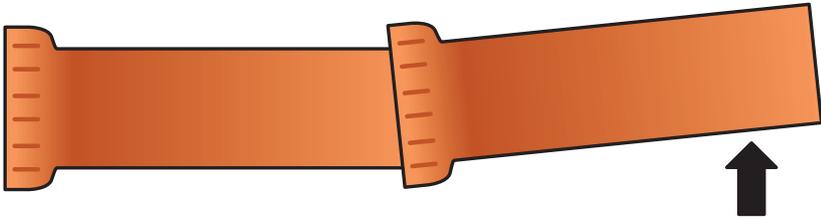
*Figure 31: Angular deflection of joints along the pipeline can be intentional to create a curvilinear sewer. Modern VCP joints will maintain the specified leak-free performance.*

The factory-applied joints of modern VCP pipe are designed to allow angular deflection while maintaining joint integrity (see the joint cutaway images on page 5 and 6). ASTM C425 (*Standard Specification for Compression Joints for Vitrified Clay Pipe and Fittings*) requires clay pipe joints to seal in angular deflection up to specified limits depending upon the pipe diameter (see the testing photos on page 7).

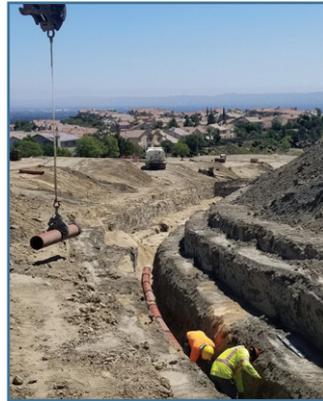
*Figure 32: Installation of a curvilinear sewer*

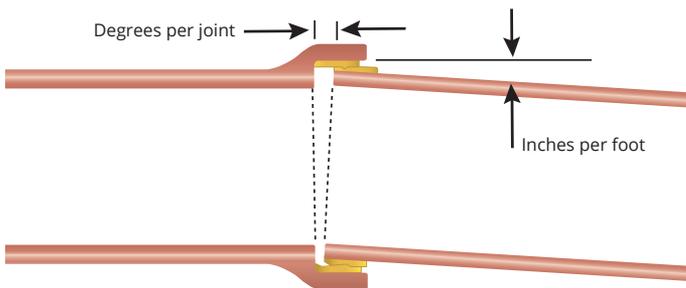
*Figure 33: Cross-sectional plan view of an assembled joint in a curvilinear sewer. Note the design measurements and the intentional gap created at the outside radius of the curve.*

Curvilinear sewers are designed using this angular deflection. Although there will be an apparent gap on one side due to the angular deflection, the joint is completely tight. See the photo below from inside the pipe to note the appearance of this condition.

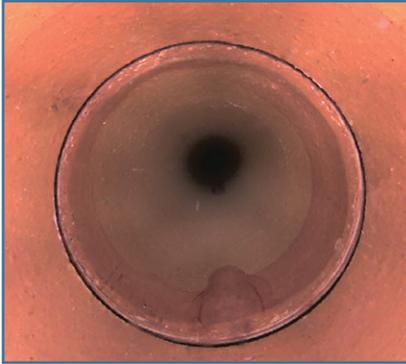
**Figure 34: Vertical Angular Deflection**  
1/2-inch per foot (Section pulled up)

Angular deflection can be used as an intentional design option to create a curvilinear pipeline. When used within ASTM limits, it does not affect the performance of the pipeline or integrity of the pipe.

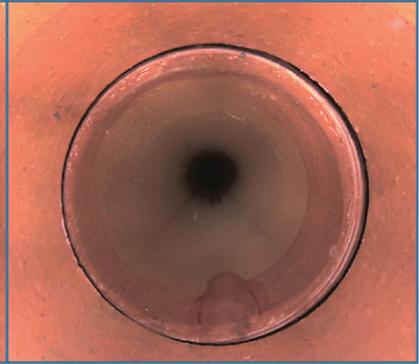
**Figure 35: Horizontal Angular Deflection**  
1/2-inch per foot (Section pulled to the left)

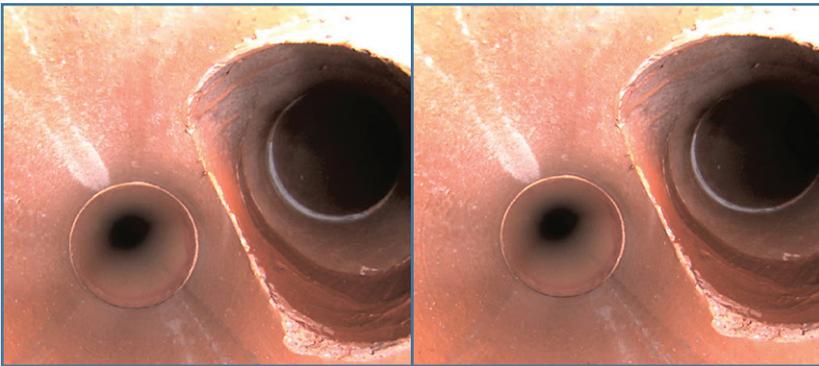
The camera in the mainline provides a partial view of the joint connection at the Y-branch spur and the curve for a service connection. Two images were captured using an 8x6-inch wye branch and a 30° curve. The first image shows a tight and square joint connection and the second has a ¾-inch gap. While the measured gaps are significantly different, they appear the same in the CCTV image from the mainline. Because of this visual similarity, an assessment cannot be made for the lateral connection via CCTV inspection from within the sewer mainline.

*Figure 36: Wye Branch connection at 30° curve: Zero angular deflection and no gap*      *Figure 37: Wye Branch connection at 30° curve: Maximum angular deflection and ¾-inch gap*
