## VCP Performance in Seismic Events

## Polyurethane “Seismic” Compression Joint for Bell and Spigot Pipe

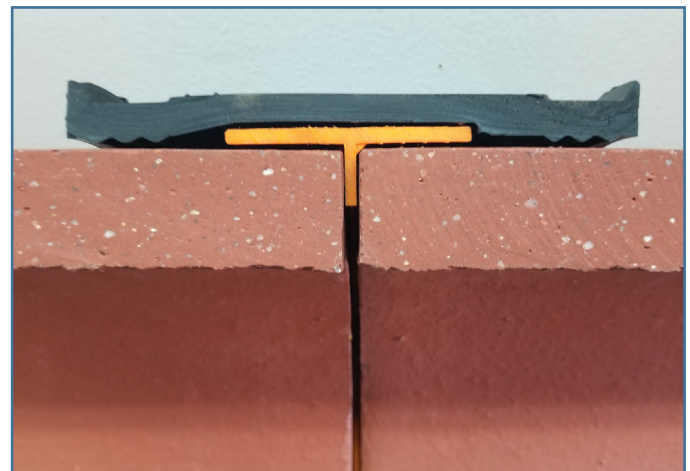
Figure 2: Plain-End VCP with rubber compression coupling, internal shear ring, and stainless steel tightening bands.

Another currently available flexible jointing system, is plain-end pipe with barrels joined by mechanical rubber compression couplings with stainless steel tightening bands (see Figure 2). These rubber couplings are equipped with either an internal or external shear load resistance device to maintain the flow line after settlement or ground movement. Like the bell and spigot joint design, this system allows for angular deflection, axial compression, shear load resistance, and some pullout.
