## Straight Alignment

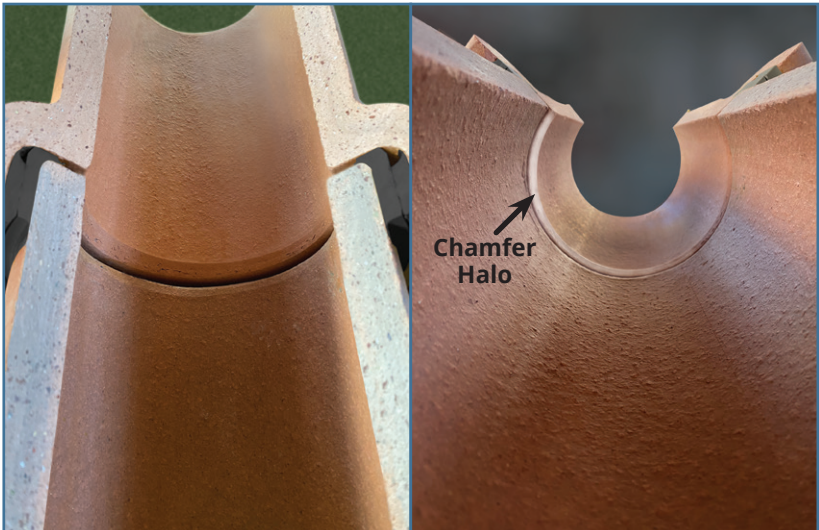
*Figure 12: Both photos above are of the same joint cross section. The image on the left shows that it is fully-homed and sealed. This same joint, viewed from the angle of a CCTV camera, (right image) shows how the gap from the seismic cushion in combination with the chamfer can reflect the light from the camera creating a halo.*

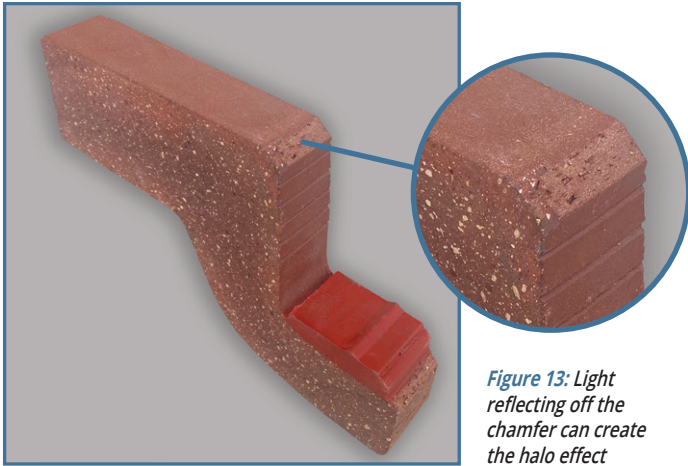
Also, the factory trimmed ends of the pipe (as shown in Figure 14) may not be perfectly concentric with the pipe presenting the illusion of an offset joint. The two images shown below are of a fully homed joint connection with no gap or offset.

The camera is not looking at the end of the pipe as it may appear, but at the trimmed/ chamfered edge of the pipe giving a halo effect. The pipe in the photos are in straight alignment. However, because the camera is looking into the bell end of the pipe, it may create an illusion of an offset, deflected or pulled joint. This illuminated halo can lead operators to incorrectly code this condition as a parallel offset or even a pulled joint.

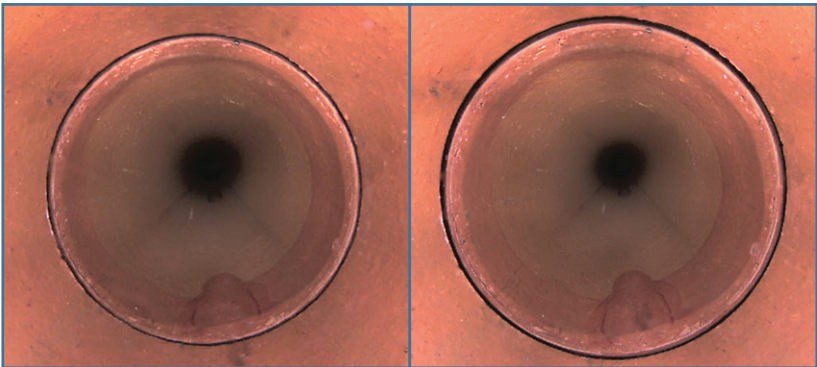
*Figure 14: Straight Alignment - approaching*

*Figure 15: Straight Alignment - close-up*
